Preliminary Archaeological Examination of the Glen Mary Plantation, Hancock County, Georgia

LAMAR Institute Publication Series, Report Number 84

By Daniel T. Elliott, The LAMAR Institute, Inc., November 11, 2004

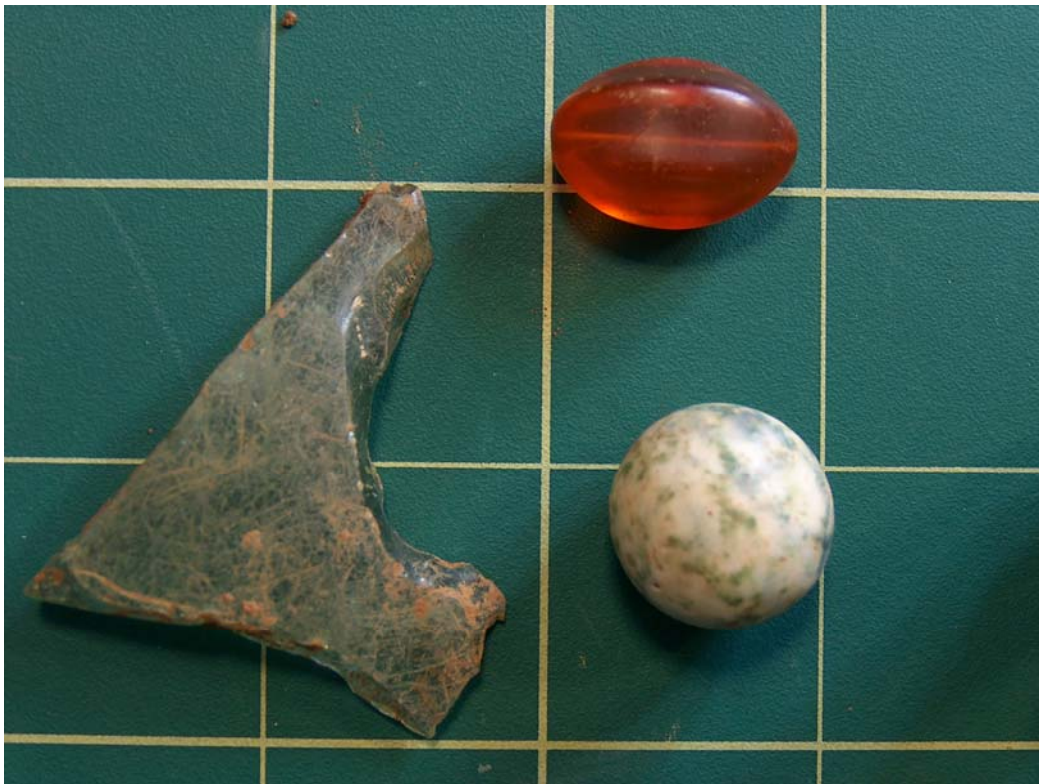
Figure 5. Selected Artifacts, Glen Mary Plantation.

Significant differences in the artifact density between the front and back yards of the dwelling were indicated by the trenches and limited shovel tests. The area of Trench 11 on the northern rear side of the house contained a noticeable increase in artifacts compared to the artifact yield from Trenches 1 through 10, which were in the front yard. This relationship of artifact frequency with increasing towards the sides and back of the manor is further confirmed by the metal detector reconnaissance information that was gathered. The Trench 11 locale contained a mixture of 19th and early 20th century artifacts, including many kitchen-related items. Selected artifacts from the project are shown in Figure 5. On the upper right is an
